# **Navajo Abandoned Uranium Mine**

## **Site Screen Report**

### **NA-0510 AUM Site**

#### **Navajo AUM Northern Region**

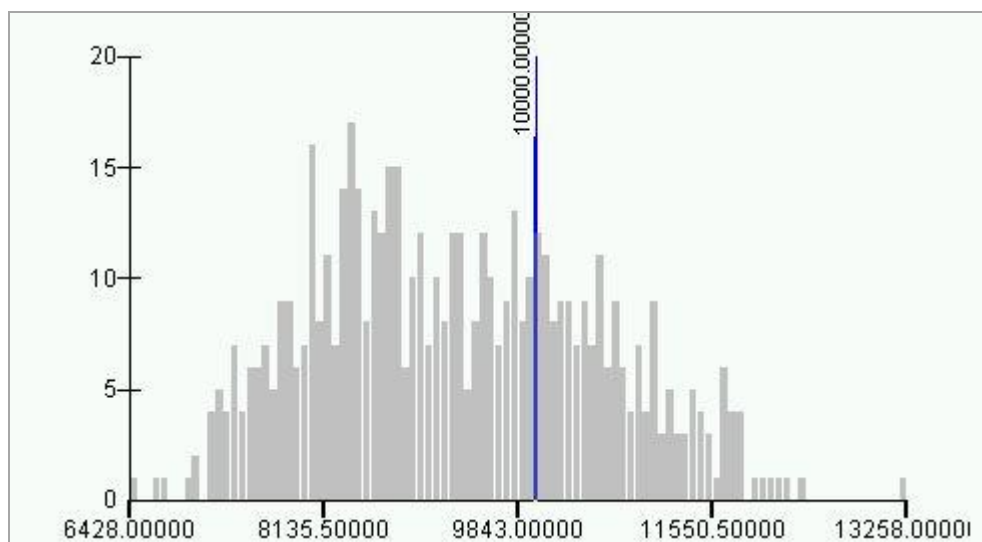
The following chart and statistics were generated by ESRI ArcGIS 9.3.1, and show the general distribution of the site gamma radiation measurements. The horizontal X axis represents the gamma radiation reading levels in cpm (lowest levels to the left). The vertical Y axis represents the frequency of each gamma radiation level.

Count:	570
Minimum:	6428.00000
Maximum:	13258.00000
Sum:	5296582.00000
Mean:	9292.24912
Median:	9200.50000
Standard Deviation:	1228.00332

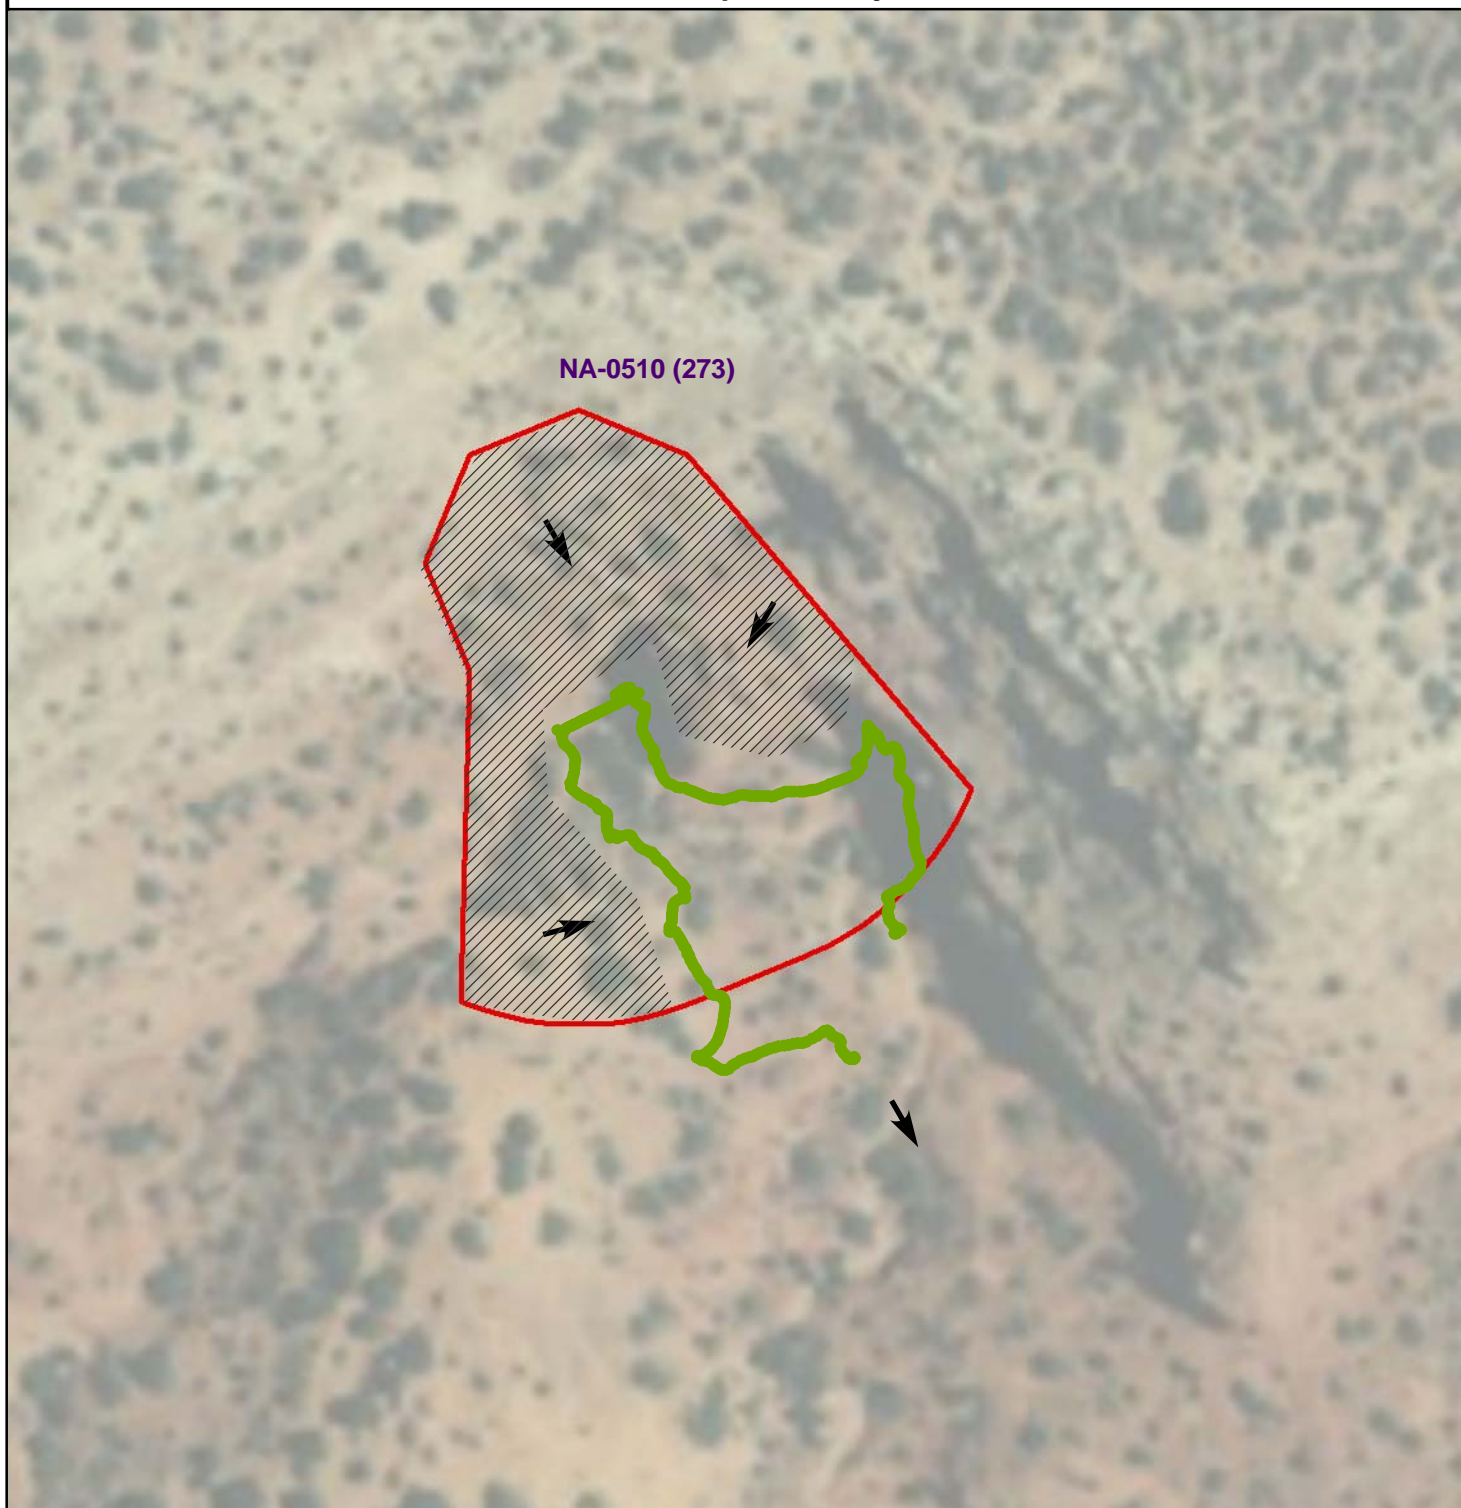
**Figure 1 - Gamma Radiation Measurements, Above Two Times Background  
NA-0510 (273)  
Sweetwater Chapter, Navajo Nation**

A total of 570 gamma radiation measurements were collected from the mine site, ranging from 6,428 cpm to 13,258 cpm. The measurements are represented in Figures 1 and 2.

Gamma survey conducted 06/2010  
Measured as counts per minute (cpm)

Average background = 9,331cpm

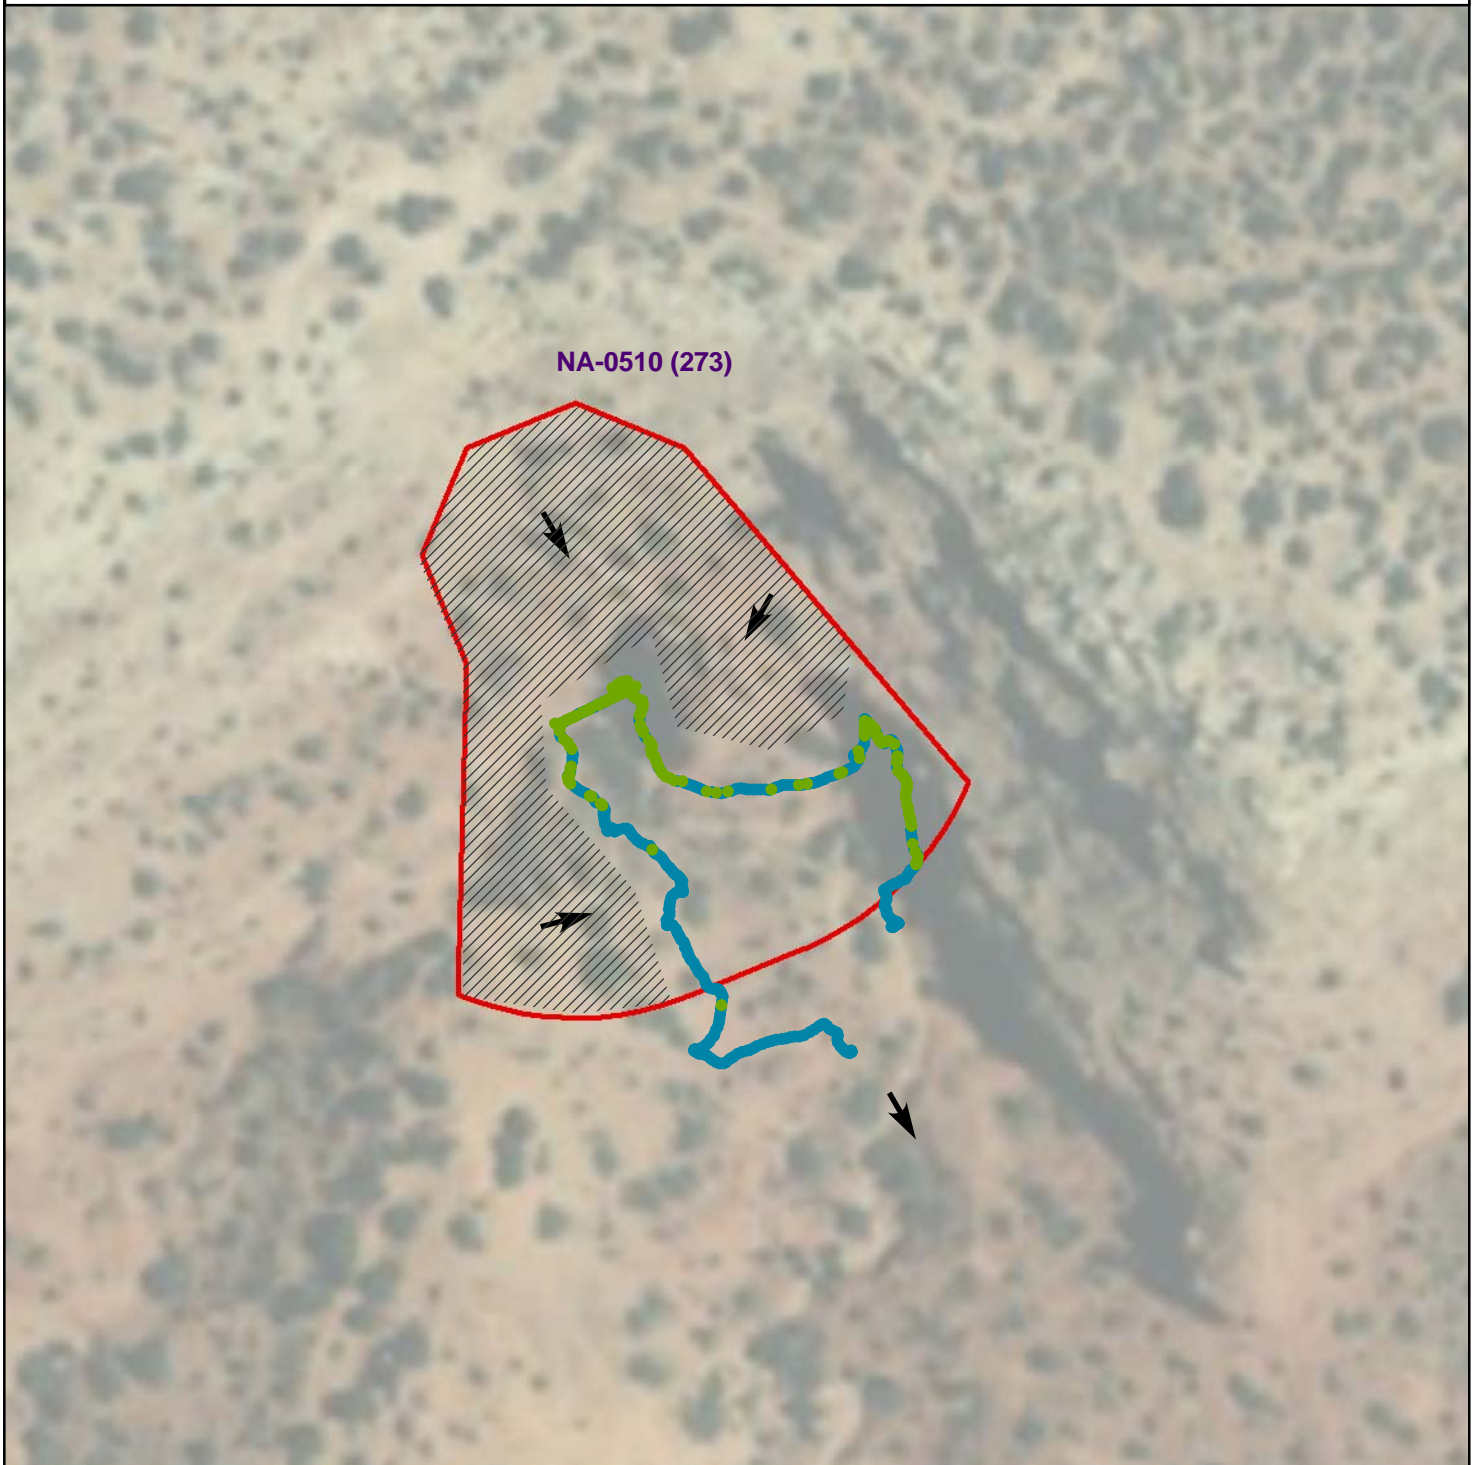
**Figure 2 - Gamma Radiation Measurements  
NA-0510 (273)  
Sweetwater Chapter, Navajo Nation**

Gamma survey conducted 06/2010  
Measured as counts per minute (cpm)

Average background 9,331 cpm
